Form Title:	<b>ENGINEERING BULLETIN</b>	Document #:	<b>EB-01-20</b>
				(Form: DEF-003A-1)
	Document Title:	<b>Important Maintenance and New Seal Design for Quick Clean Hydraulic Valve</b>	Revision:	<b>0</b>
				Date:
			Page:	<b>1 of 3</b>

**Description of Bulletin:** This bulletin addresses an important maintenance procedure required to ensure increased performance of Betts Quick Clean Hydraulic Valves as well as introduces a new double barrel seal system that will improve the effectiveness of the bore seal joint.

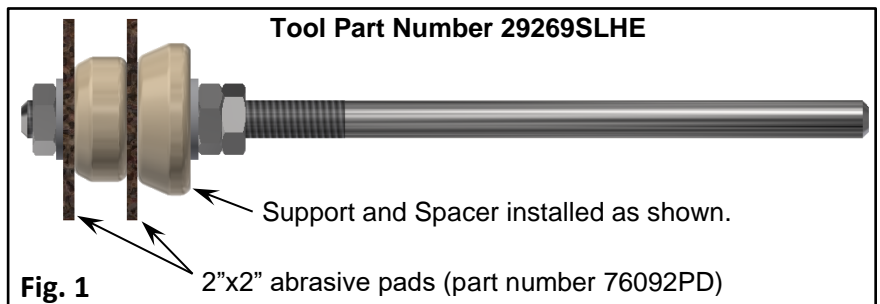
4. Ensure the clean-out tool has new sanding pads installed. The pads should be 2"x2" fine grit abrasive pads installed as shown in figure 1. Make sure the nuts are tightened down to ensure the pads do not spin on the tool.

Quick Clean Hydraulic Stuffing Box Bore Clean-out Tool part number 29269SLHE. **\*\* Improper seat condition is one of the leading causes of valve failure. \*\***

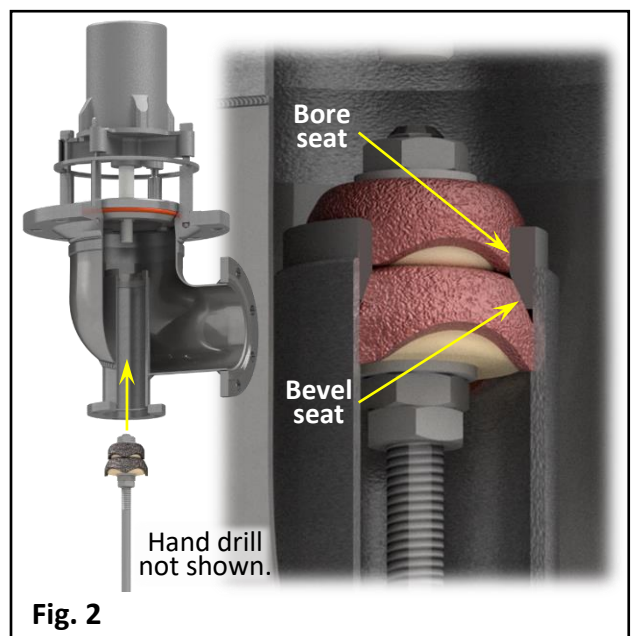
6. Insert the bore clean-out tool into the bore of the Quick Clean Hydraulic stuffing box (See Fig. 2). Run the drill at a slow speed of roughly 200 to 400 RPM while applying moderate force to the tool.

7. Insert the sanding hub fully into the bore several times to ensure the bore and bevel seat are adequately cleaned and polished. (See Fig. 2)

8. After using the tool, blow out the stuffing box with compressed air and clean the bevel seat and barrel cap bore seat with a clean rag.

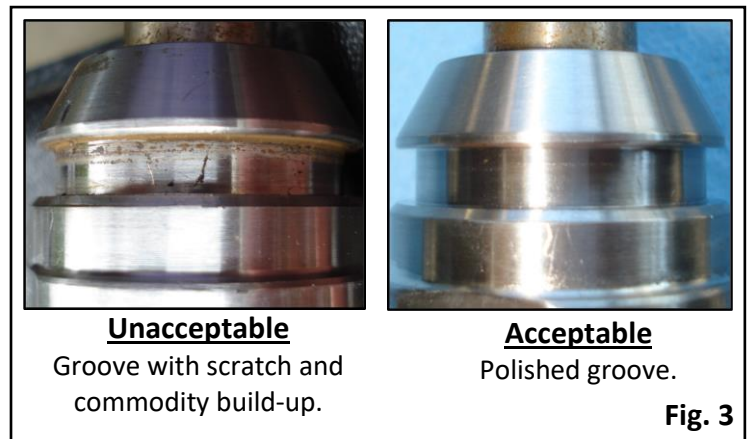
14. See figure 3 for a view of an unacceptable groove and a view of the same groove that has been polished to an acceptable state. Replace the actuator if the groove cannot be repaired.

13. Inspect groove for damage or commodity build-up. Use a fine grit abrasive pad or sandpaper to completely clean and dress the groove sealing surface. The surface of the groove should be smooth and free of all scratches or commodity build-up.

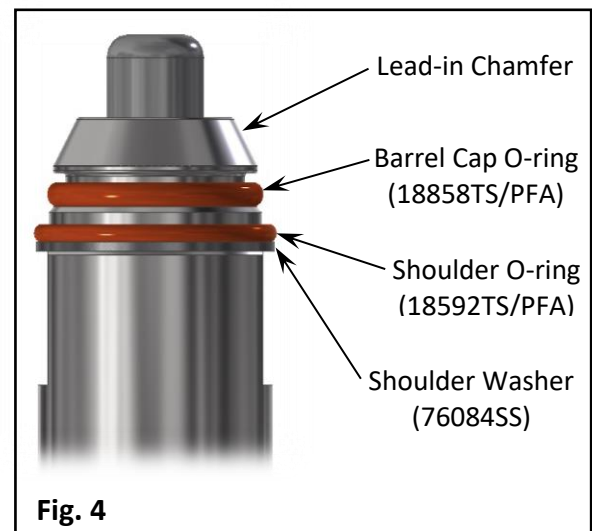
15. Inspect the large lead-in chamfer of the actuator as shown in figure 4. Chamfer must be smooth and free of all nicks or sharp edges.
16. The Quick Clean Hydraulic Valve Barrel Cap Seal Upgrade Kit is part number 76084SSTS. It includes a shoulder washer (76084SS), a shoulder O-ring (18592TS/PFA) and a barrel cap O-ring (18858TS/PFA).

18. As shown in figure 4, install the shoulder washer followed by the shoulder O-ring.
19. Next carefully stretch the barrel cap O-ring over the lead-in chamfer and install into the barrel cap groove. For detailed instructions see manual MM CH002.
